Slope degradation and analysis of Mokattam plateau, Egypt

Keywords: Mokattam city, Eocene, landslides, marl, shale, edge failure, water infiltration

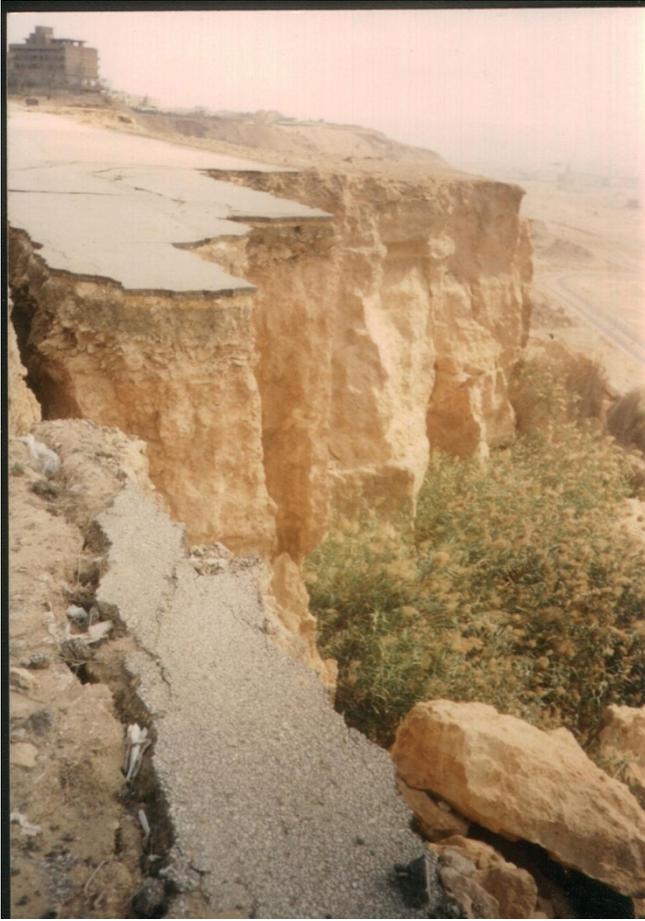
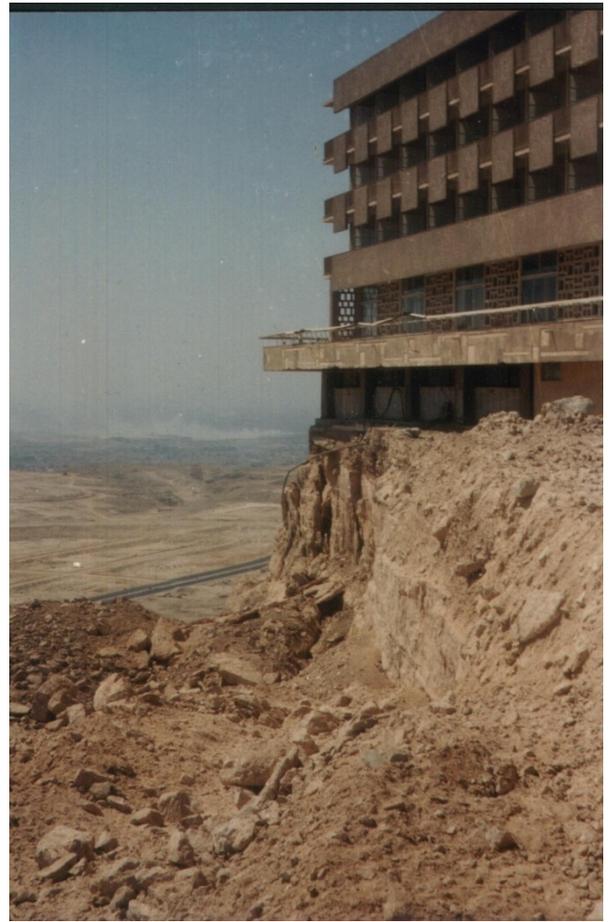
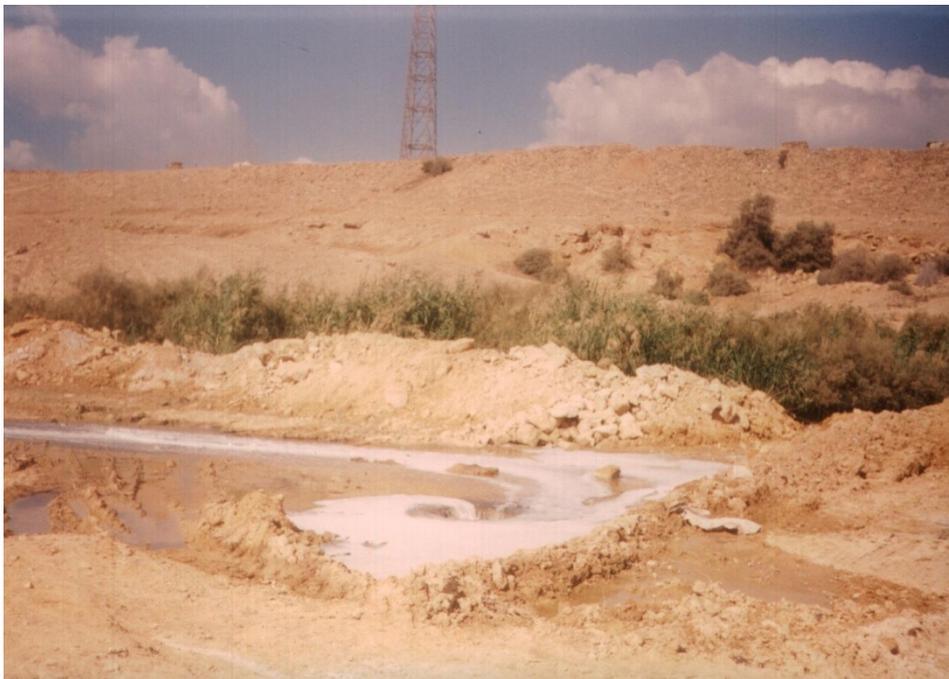
rock falls were observed. The most significant of this was an edge failure that occurred in front of a five-storey hotel. The rock mass that slipped reached the edge of this hotel and left the corner column almost overhanging (see photos). Since then, several investigations on the incidents were launched to assess the causes, future hazards and probable protective or mitigation measures (EGSMA, 1996; El-sohby and Eleboudy, 1988; El-sohby et al. 1987 and Elleboudy, 1985). However, the studies were usually for particular zones and addressed local failures.

Some photos showing land slide activity
