Slope degradation and analysis of Mokattam plateau, Egypt

Keywords: Mokattam city, Eocene, landslides, marl, shale, edge failure, water infiltration

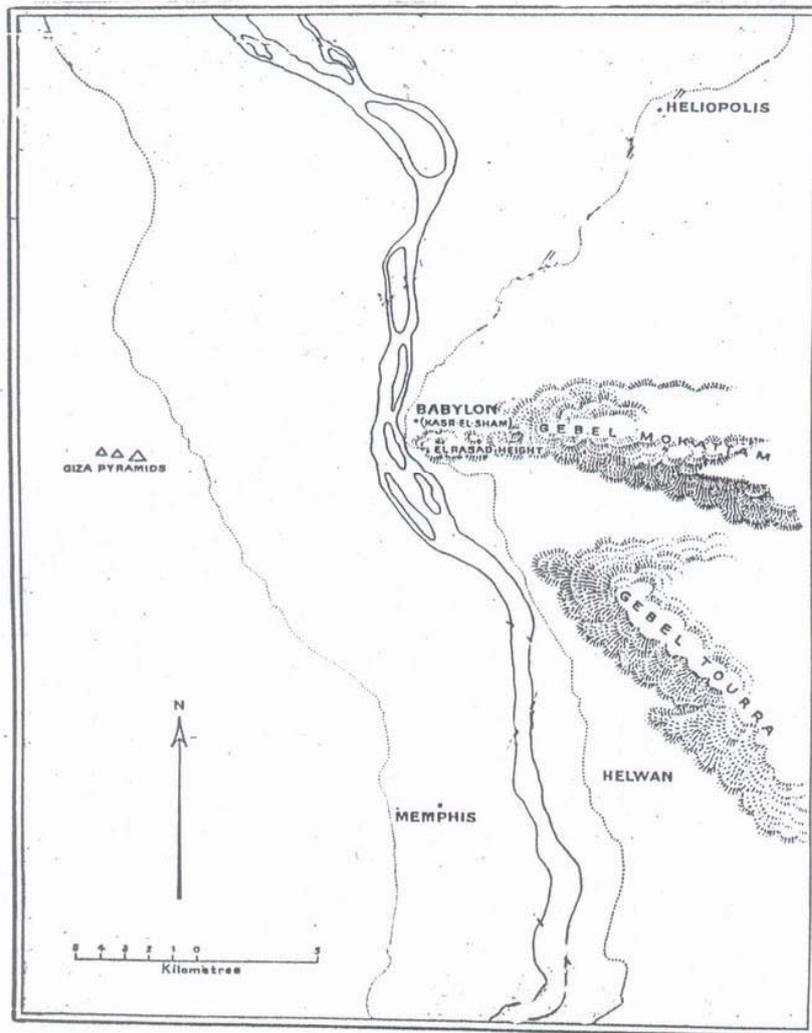
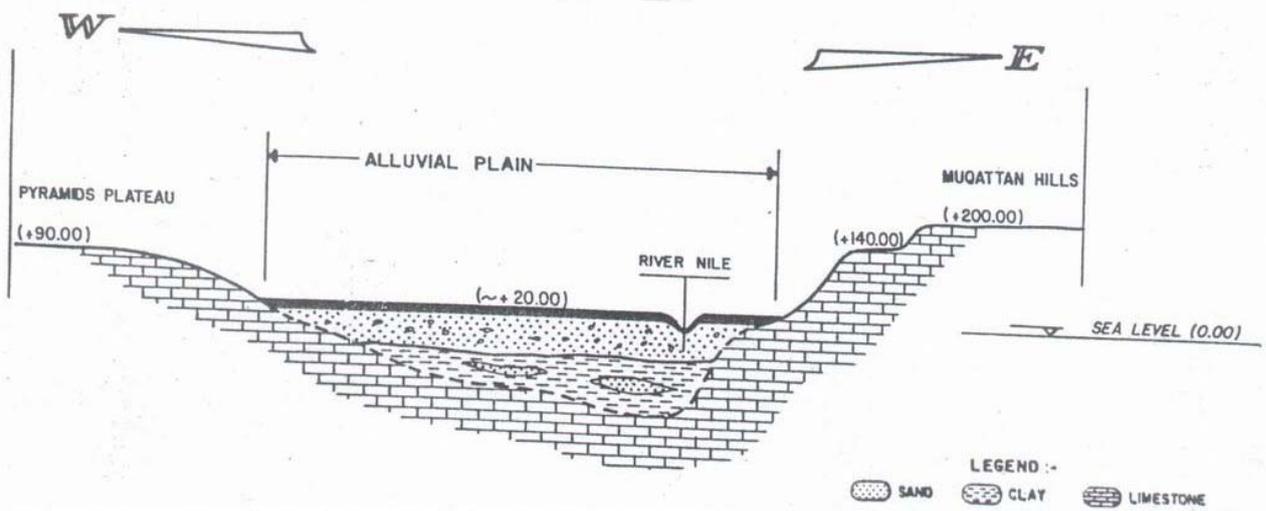
Figure 1. General layout of Mokattam hill (at the site of Cairo)

rock falls were observed. The most significant of this was an edge failure that occurred in front of a five-storey hotel. The rock mass that slipped reached the edge of this hotel and left the corner column almost overhanging (see photos). Since then, several investigations on the incidents were launched to assess the causes, future hazards and probable protective or mitigation measures (EGSMA, 1996; El-sohby and Eleboudy, 1988; El-sohby et al. 1987 and Elleboudy, 1985). However, the studies were usually for particular zones and addressed local failures.

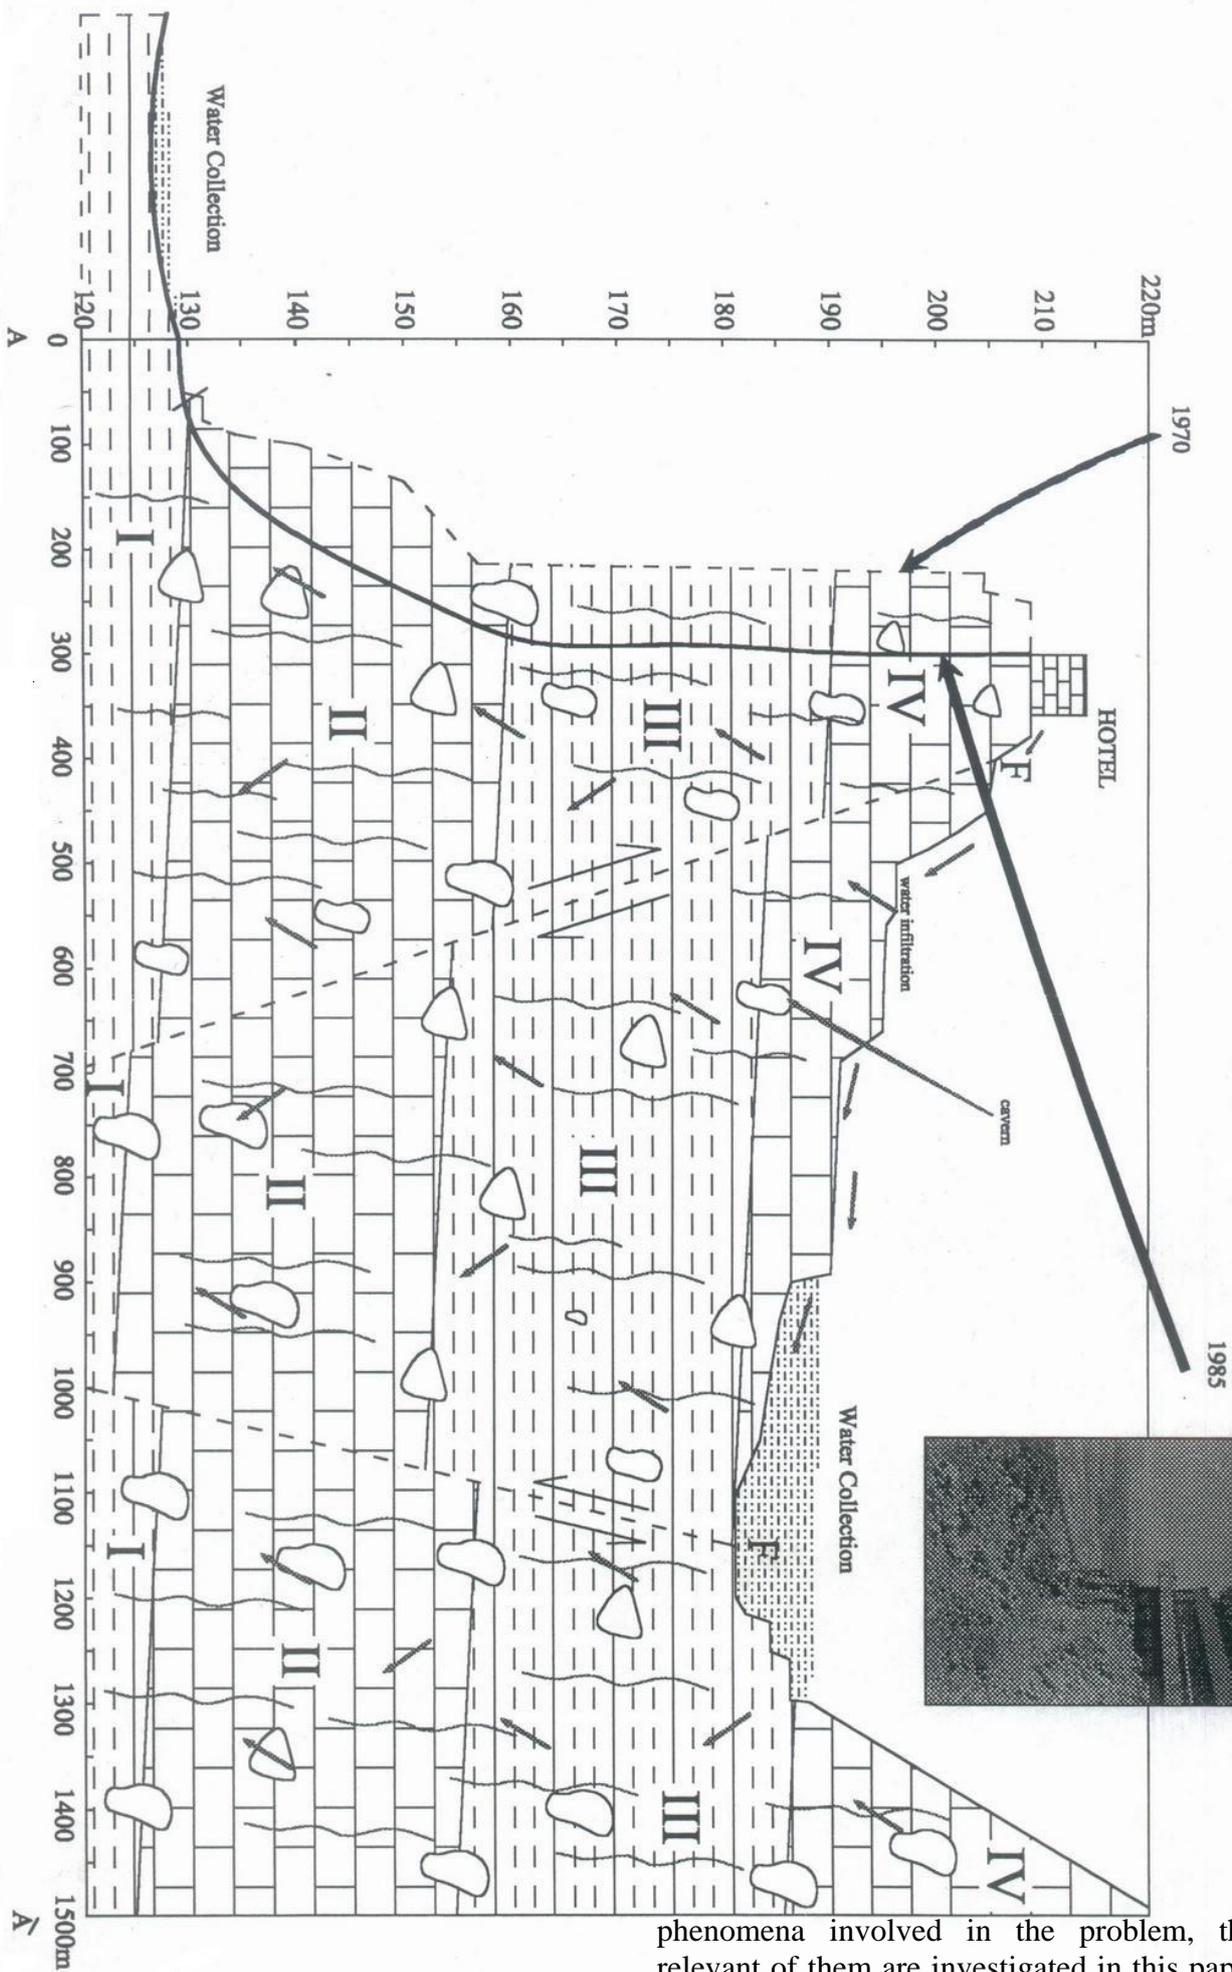
Figure 2. Geological cross section through the studied area

According to (Aboushook and Sherif, 2000; EGSMA, 1996 and Said, 1962) and as seen in Fig. 2. Maadi formation include the following (from top to bottom):

- 1- Medium to strong yellowish white dolomitic limestone becoming sandy towards the base, some fissures & caverns, traces of gypsum pockets) and is denoted by “ IV “ - (6 m average thickness).
- 2- Alternating yellowish sandy and grayish shale beds with minor intercalation of marls & salts, some fissures & caverns and is denoted by “ III “ - (40 m average thickness).
- 3- Fissured and cavernous weak to medium yellowish brown limestone, some marl and gypsum pockets and is denoted by “ II “ - (20 m average thickness).
- 4- Alternating yellowish sandy and grayish shale beds with minor intercalation of marls & salts, some fissures & caverns and is denoted by “ I “ - (10 m average thickness).
